DEPARTMENT OF TRANSPORTATION

Contract #: 04-0120F4Cty: SF/ALA Rte: 80 PM: 13.2/13.9File #: 69.28**WELDING INSPECTION REPORT****Resident Engineer:**Siegenthaler, Peter**Address:** 333 Burma Road**City:** Oakland, CA 94607**Report No:** WIR-020675**Date Inspected:** 11-Feb-2011**Project Name:** SAS Superstructure**OSM Arrival Time:** 1900**Prime Contractor:** American Bridge/Fluor Enterprises, a JV**OSM Departure Time:** 700**Contractor:** Zhenhua Port Machinery Company, Ltd (ZPMC), Changxing Island **Location:** Shanghai, China**CWI Name:** See below**CWI Present:** Yes No**Inspected CWI report:** Yes No N/A**Rod Oven in Use:** Yes No N/A**Electrode to specification:** Yes No N/A**Weld Procedures Followed:** Yes No N/A**Qualified Welders:** Yes No N/A**Verified Joint Fit-up:** Yes No N/A**Approved Drawings:** Yes No N/A**Approved WPS:** Yes No N/A**Delayed / Cancelled:** Yes No N/A**Bridge No:** 34-0006**Component:** OBG**Summary of Items Observed:**

WELDING INSPECTION REPORT

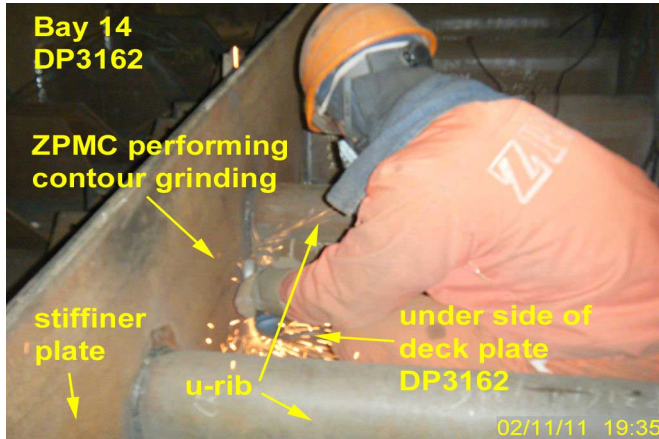
Components; 13E (see photo below)

PCMK: SEG3007BB

Weld No: 081

Welder: 215553

Weld Repair: CWR2737

WPS-345-SMAW-2G(2F)-FCM-Repair-1
